RM SE51F08

EFFECT OF ANGLE OF INCIDENCE OF SECOND-STAGE VANE

ASSEMBLY ON THIRD-STAGE COMPRESSOR-BLADE

VIBRATION AND ENGINE PERFORMANCE

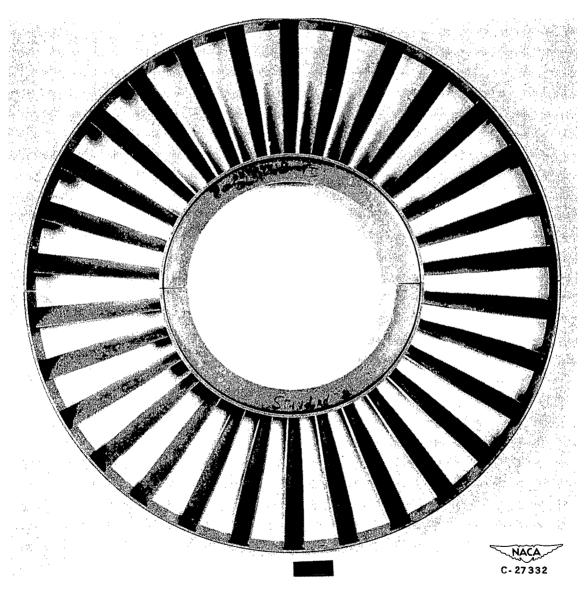
After the third-stage vibration had been detected, a series of tests followed which included the testing of a series of second-stage stator-vane assemblies (fig. 1) with various angles of incidence. The assemblies tested included 6° open, 0° (standard), 3° closed, 6° closed, 9° closed, and 12° closed. The standard vane is the vane assembly normally furnished with the engine, and the closed angle indicates a vane with higher angle or incidence.

Figure 1. - Second-stage vane assembly.

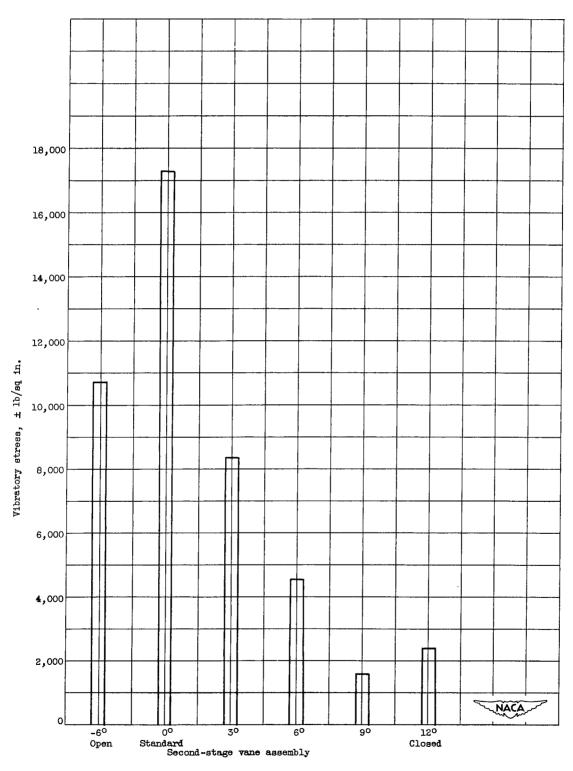
Angle of incidence	Vane assemblies investigated	Average vibratory stress in third- stage blades (lb/sq in.)	Percentage of standard stress
60 open	3	±10,700	62.0
00 (standard)	2	±17,250	100.0
30 closed	1	± 8,350	48.4
60 closed	5	± 4,550	26.4
9 ⁰ closed	1	± 1,600	9.3
12 ⁰ closed	3	± 2,400	13.9

A change of 3° closed reduced the vibratory stress to less than half and would possibly bring the vibration below the danger point. A change, however, to 9° greater incidence would assuredly eliminate all third-stage vibration failures of this compressor design in the critical speed range.

Figure 2. - Effect of second-stage vane-assembly angle of incidence on third-stage vibration.

- 1. The 9° closed vane assembly produced the lowest vibration amplitude of the third-stage rotor blades.
- 2. A change of 180 in the second-stage vane assembly had little or no effect on the over-all engine performance.

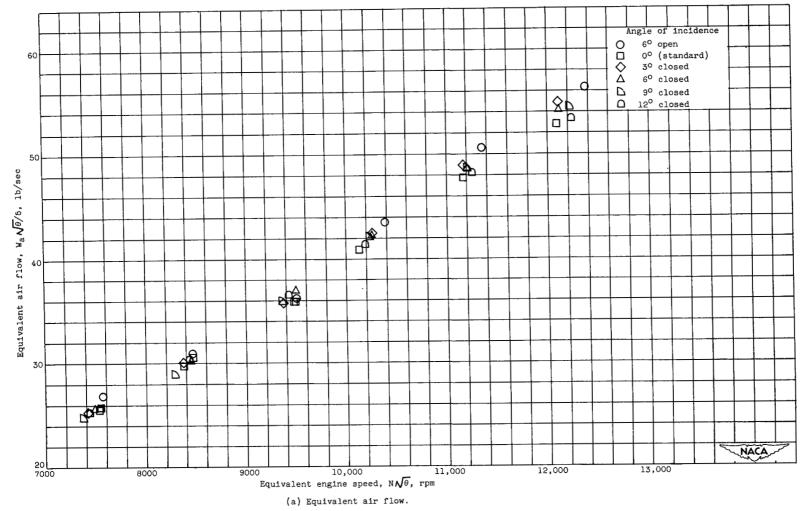
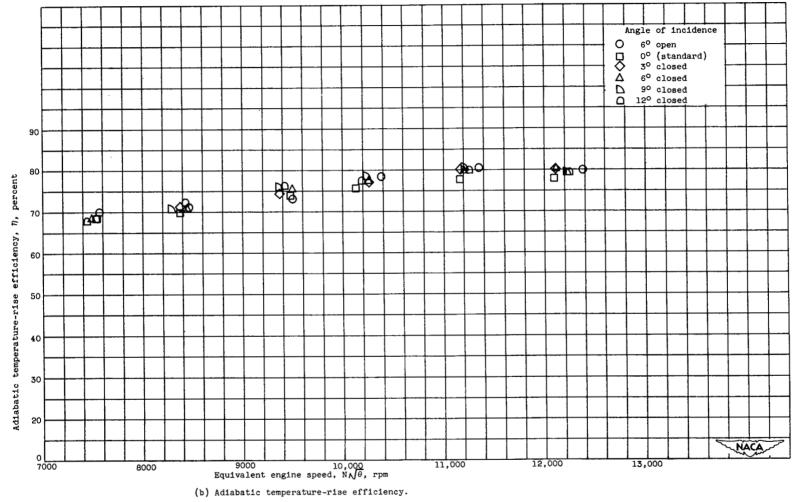
The complete speed range (to 12,500 rpm) was investigated with vanes of each angle from the vibration standpoint as well as to determine engine performance. No new vibration of significant amplitude was introduced by any of the new angles. The effects on over-all engine performance is illustrated in figures 3 and 4. Although a total change of 18° (6° open to 12° closed) was investigated, very little or relatively no change in engine performance was detected.

Figure 3. - Performance characteristics of J34 compressor with various second-stage vane-assembly angles of incidence.

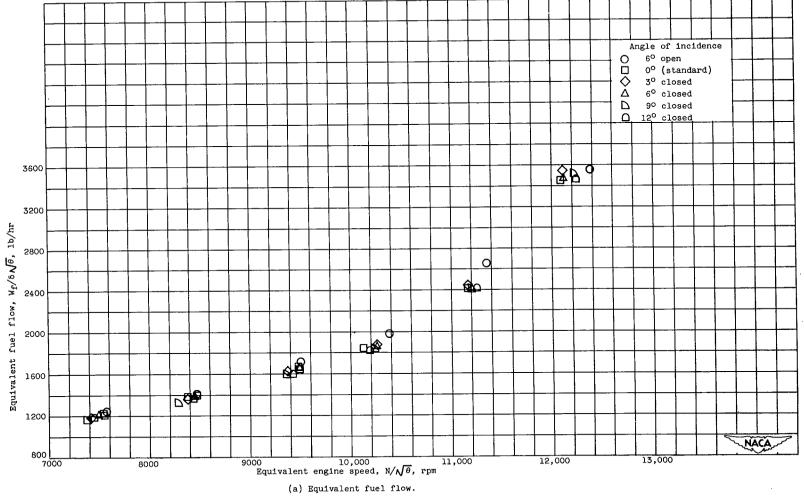
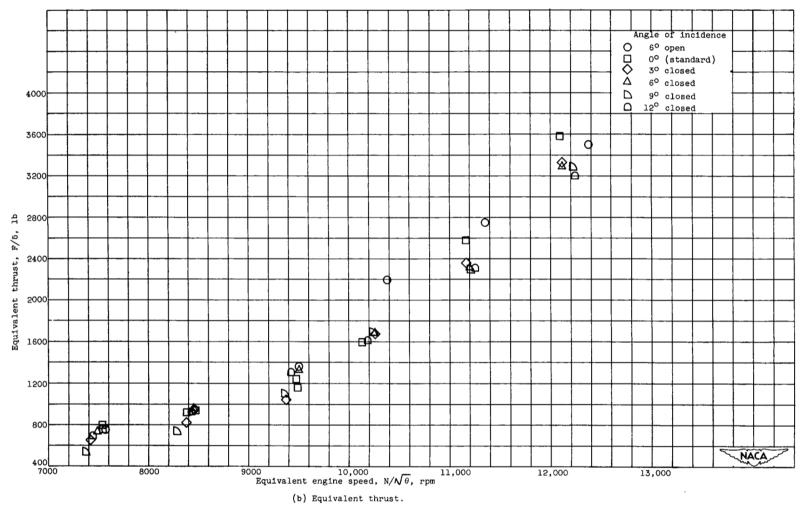
Figure 4. - Performance characteristics of J34 engine with various second-stage vane-assembly angles of incidence.
